***Preliminary Geotechnical Investigation of Proposed WWTP Site***

# Marion Waste Water Treatment Plant

Subject: Preliminary Geotechnical Investigation  
Marion Waste Water Treatment Plant  
Marion, Kentucky  
CSI Project No. LV170004

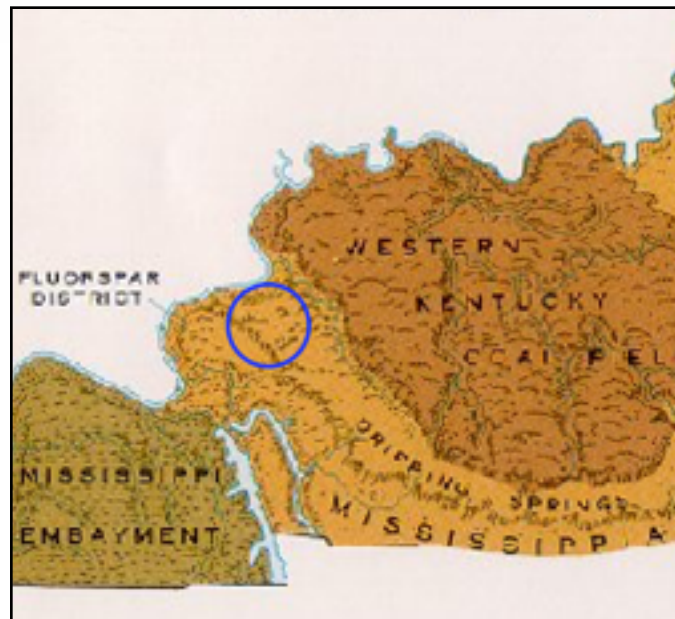
**Figure 1.** Kentucky Physiographic Map  
(site vicinity shown in the circle)

Published topographic mapping by the USGS (United States Geologic Survey) indicates the elevations in the project site vicinity range from approximately 540 feet to 620 feet. Figure 1 shows the location of the site with respect to the regional physiography.

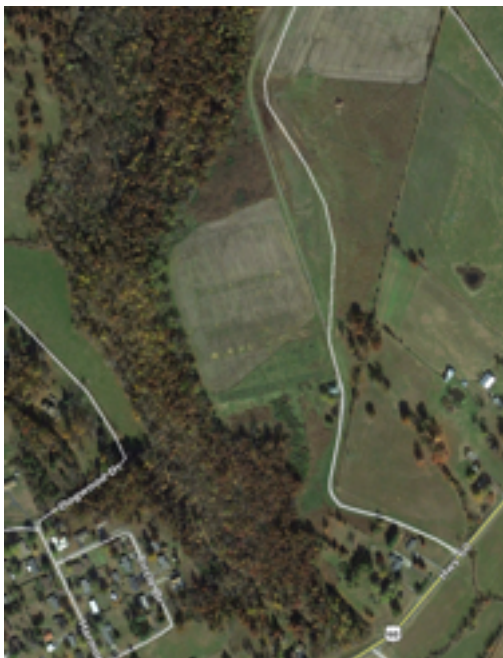
**Figure 6.** Aerial photo of the site area,  
dated November 6, 2013  
(Google Earth Image)

- The project site was occupied by eight rows of structures, which were assumed to be used as poultry operation structures, and the structures were demolished between June 2004 and June 2006.
- The project site was regraded between May 2011 and November 2013.
- Pippi Hardin Boulevard was built along the east edge of the project site between November 2013 and October 2015.
- Please reference the aerial photographs above for further details.

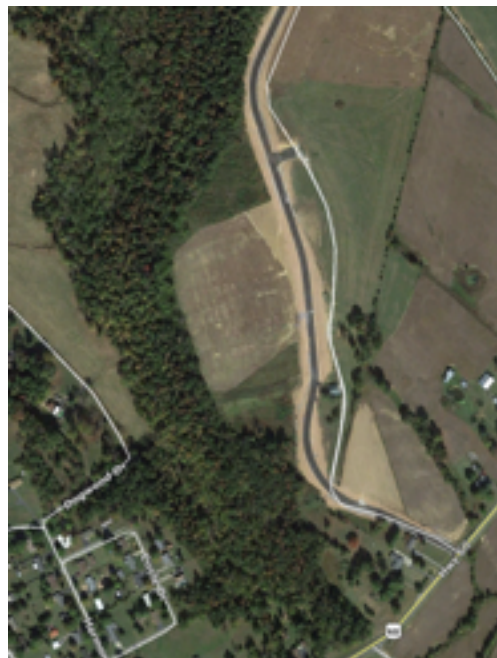
**Figure 7.** Aerial photo of the site area,  
dated October 15, 2015  
(Google Earth Image)

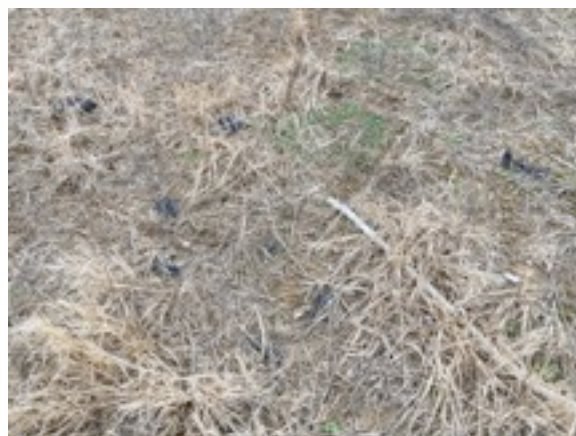
**Photo 4.** View of observed plastic sewer pipes and cables

At the time of our site visit, the ground cover consisted primarily of ankle-high grass and mature bushes. Concrete blocks, plastic sewer pipes, cables, and abandoned gas poles were observed across the site. Along the west side of Pippi Hardin Boulevard, signs of utility construction were observed.

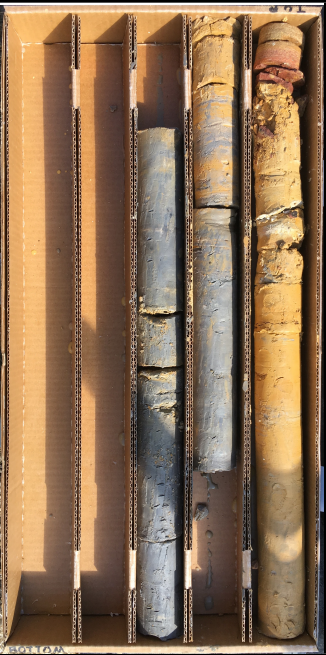
Boring	Run	Description and Notes	Photo of Core
B-103	from 13.4 feet to 18.4 feet deep	<p>Highly weathered shale with two inches of sandstone cap on top and multiple sandstone seams at upper two feet, no core water loss observed</p> <p>Sandstone - reddish brown, medium to coarsely crystalline, hard</p> <p>Shale - gray to dark gray, highly weathered and sometimes soil-like, brittle with little moisture and soft with higher moisture</p> <p>Recovery: 100% RQD: 79% (good engineering quality)</p>

**Table 4. Rock Core Summary**  
(Top of rock core shown in picture is at the upper right corner of the photo)

Auger refusal was encountered at three of our soil borings. Auger refusal depths ranged from approximately eleven to twenty-one feet. We have interpreted auger refusal to be the top of bedrock. Refusal material was sampled by coring rock at boring B-103. The rock core is summarized below.

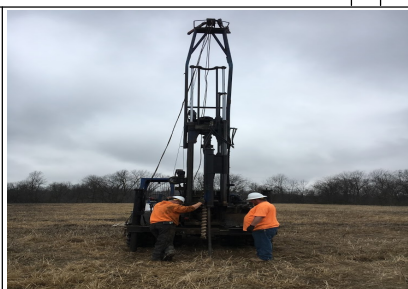
Left Photo: Photo of Approximate Boring Location  
Right Photo: Photo of Boring

Elev. (ft)	Depth (ft)	Symbol	Description	Blow Counts (N Value)	Recov. (in)	Water Level	Remarks
110			TOPSOIL - 4 inches	2-3-5 (8)	16		Dry upon completion of soil augering
	2	CL	LEAN CLAY with Sand (CL) - FIRM to VERY STIFF, brown and gray, with black mottling, moist	6-9-10 (19)	18		
108							
	4						
106							
	6			8-9-10 (19)	18		
104							
	8			5-7-10 (17)	18		
102							
	10	CL	LEAN CLAY (CL) - VERY STIFF, brown and gray, with black mottling, with reddish-brown rock fragments, moist	8-9-9 (18)	18		
100							
	12						
98							
	14			4-11-50/2"	14		
96			SANDSTONE - reddish-brown, severely weathered, dry				
	16						
94							
	18						
92				50/1"	0		
	20		Auger Refusal at 20.6 feet				
90							
	22						
88							
	24						
86							
	26						
84							
	28						
82							
	30						
80

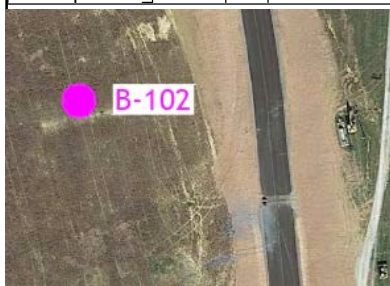
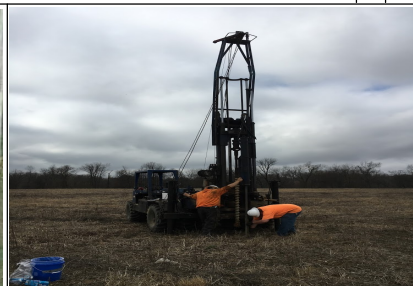
Left Photo: Photo of Approximate Boring Location  
Right Photo: Photo of Boring

Elev. (ft)	Depth (ft)	Symbol	Description	Blow Counts (N Value)	Recov. (in)	Water Level	Remarks
104	2		TOPSOIL - 4 inches	3-5-4 (9)	18		Dry upon completion of soil augering
102	4		Possible FILL - sampled as STIFF, brown and gray clay, moist	4-6-5 (11)	10		
100	6		FILL - sampled as FIRM, greenish-gray clay, with buried topsoil, with organic debris (grass and fine roots), moist	3-4-4 (8)	18		
98	8		LEAN CLAY (CL) - FIRM to STIFF, brown and gray, moist	2-3-5 (8)	18		
96	10	CL		3-5-6 (11)	18		
94	12						
92	14						
90	16	CL	LEAN CLAY (CL) - STIFF to VERY STIFF, brown and gray, with reddish-brown rock fragments, moist	4-7-9 (16)	18		
88	18		SHALE - dark gray, highly weathered				
86	20			10-14-15 (29)	18		
84	22		Boring Terminated at 20.5 feet				
82	24						
80	26						
78	28						
76	30						
74

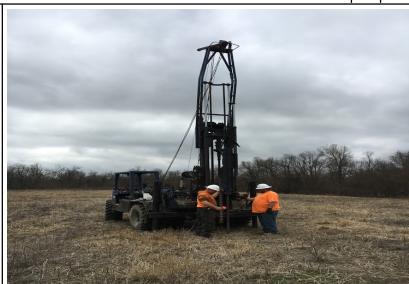
Left Photo: Photo of Approximate Boring Location  
Right Photo: Photo of Boring

Elev. (ft)	Depth (ft)	Symbol	Description	Blow Counts (N Value)	Recov. (in)	Water Level	Remarks
104			TOPSOIL - 6 inches	1-3-5 (8)	18		Dry upon completion of soil augering
102	2	CL	LEAN CLAY (CL) - FIRM to VERY STIFF, brown and gray, moist	7-8-16 (24)	14		
100	4		SANDSTONE - reddish-brown to pinkish-red, highly weathered, with rock fragments from 2.8' - 6.5'	50/3"	3		
98	6			50/1"	1		
96	8			50/0"	0		
94	10						No core water loss observed REC (%) - 100 RQD (%) - 79
92	12						
90	14		Auger Refusal at 13.4 feet Begin Coring at 13.4 feet				
88	16		SANDSTONE - HARD, reddish-brown, medium to coarsely crystalline		60		
86	18		SHALE - SOFT, gray to dark gray, highly weathered, with sandstone seams from 13.6' - 15.6'				
84	20		Coring Terminated at 18.4 feet				
82	22						
80	24						
78	26						
76	28						
74	30

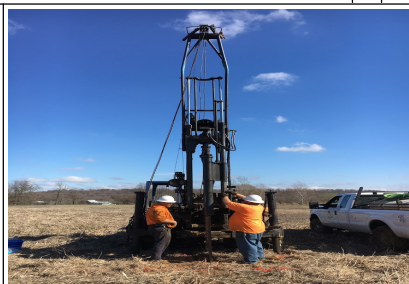
Left Photo: Photo of Approximate Boring Location  
Right Photo: Photo of Boring

Elev. (ft)	Depth (ft)	Symbol	Description	Blow Counts (N Value)	Recov. (in)	Water Level	Remarks
102			TOPSOIL - 7 inches	2-1-3 (4)	15		Dry upon completion of soil augering
100	2	CL	LEAN CLAY (CL) - SOFT to VERY STIFF, brown and gray, moist	4-8-12 (20)	16		
98	4			7-9-11 (20)	18		
96	6			50/4"	4		
94	8		SANDSTONE - reddish-brown to pinkish-red, highly weathered	50/1"	1		
92	10		Auger Refusal at 10.9 feet				
90	12						
88	14						
86	16						
84	18						
82	20						
80	22						
78	24						
76	26						
74	28						
72	30
